Biological and Water Quality Assessment of Upper Des Plaines River Subwatersheds: Year 1 Rotation 2017

**Biological and Water Quality Assessment of Upper Des Plaines River
Subwatersheds: Year 1 Rotation 2017**

Indian, Buffalo, and Aptakisic Creek Subwatersheds.

Technical Report MBI/2017-10-10

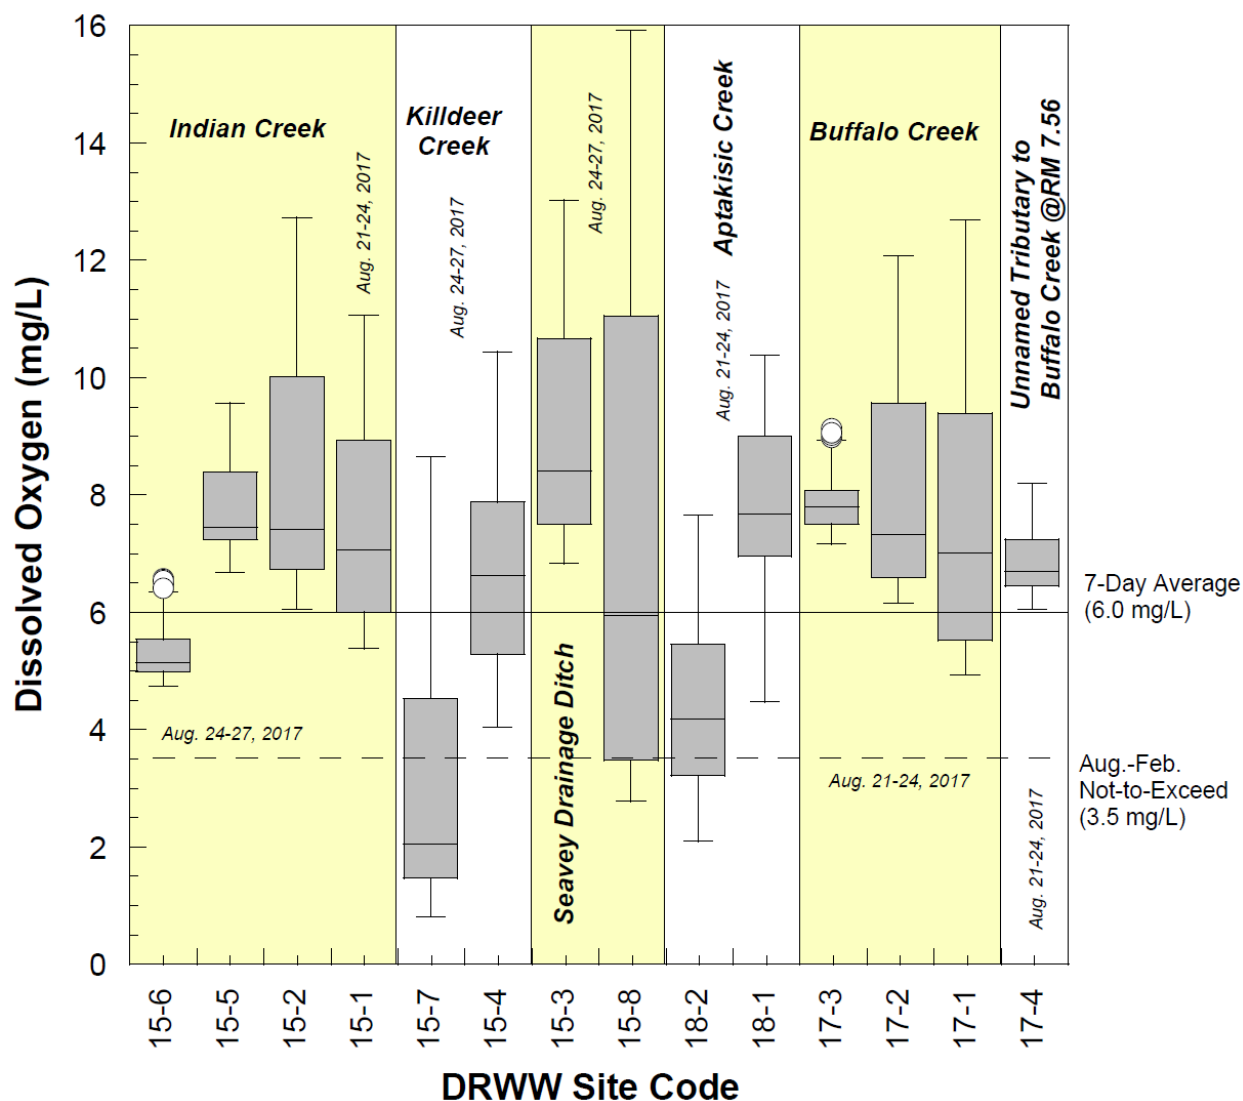
Figure 6. Dissolved oxygen (D.O.) concentrations (mg/L) measured continuously by Datasondes deployed for 3-4 day periods during August 21-24 and 24-27, 2017 at 14 locations in the 2017 study area. Box-and-whisker plots show the minimum, maximum, 25th and 75th percentiles, median, and outlier (>2 interquartile ranges from the median) values. The IEPA August-February minimum (3.5 mg/L) and the 7-day average D.O. criteria are shown by solid and dashed lines.

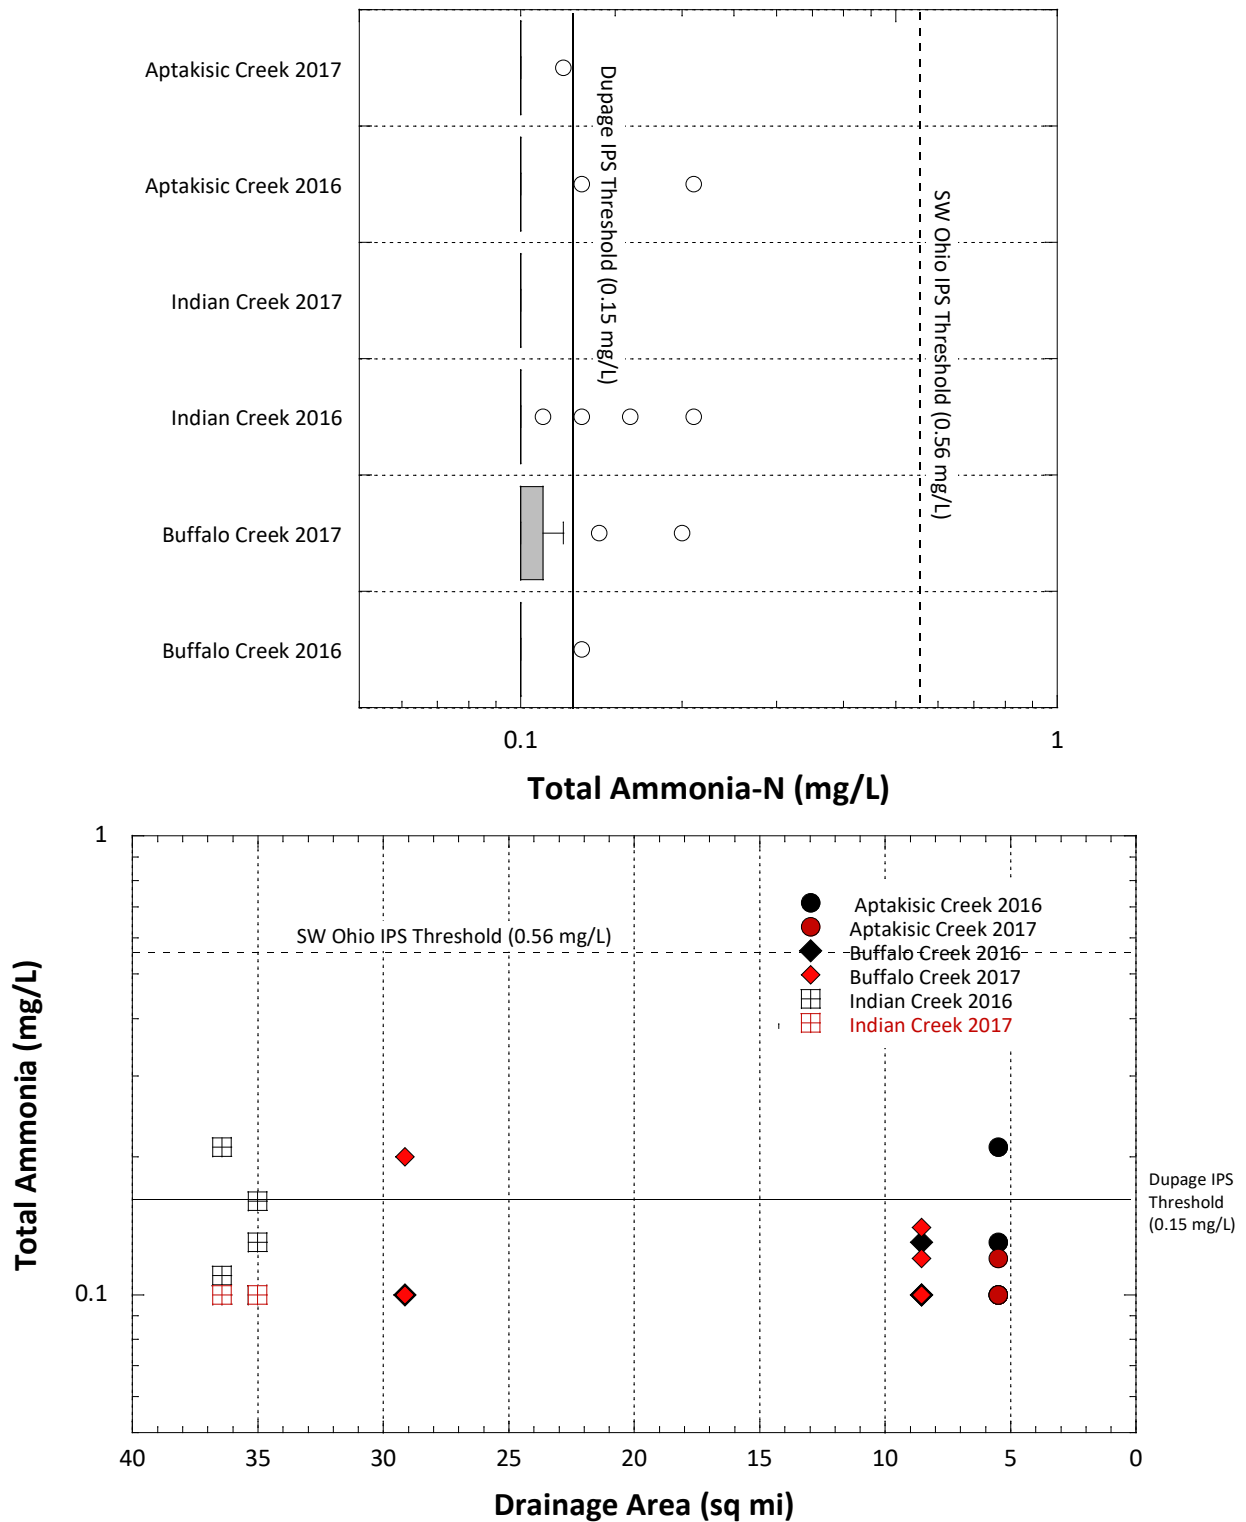
Figure 7. Concentrations of ammonia-N by subwatershed and stream in the Year 1 2017 study area. Raw values in tributary subwatersheds are shown as box-and-whisker plots (upper panel, shaded boxes) and by individual site by drainage area (lower panel) in 2016 and 2017. Dashed and solid lines represent effect thresholds correlated with impaired biota in the DuPage River-Salt Creek IPS study (0.15 mg/L) and the SW Ohio IPS study (0.56 mg/L).

Levels of ammonia-N were either below or just above the mean detection level (MDL) with no values that would suggest either chronic or acutely toxic effects to aquatic life (Figure 7). Detectable values in 2017 were less frequent than in 2016 presumably due to the higher flows in 2017. In terms of effect thresholds all values were below the SW Ohio threshold of 0.56 mg/L and only a few results exceeded the DRSCW IPS threshold of 0.15 mg/L. There were no outlier values measured downstream of the Lake Co. Des Plaines River WWTP in Aptakistic Creek based on grab samples collected at RM 0.5 (18-1).

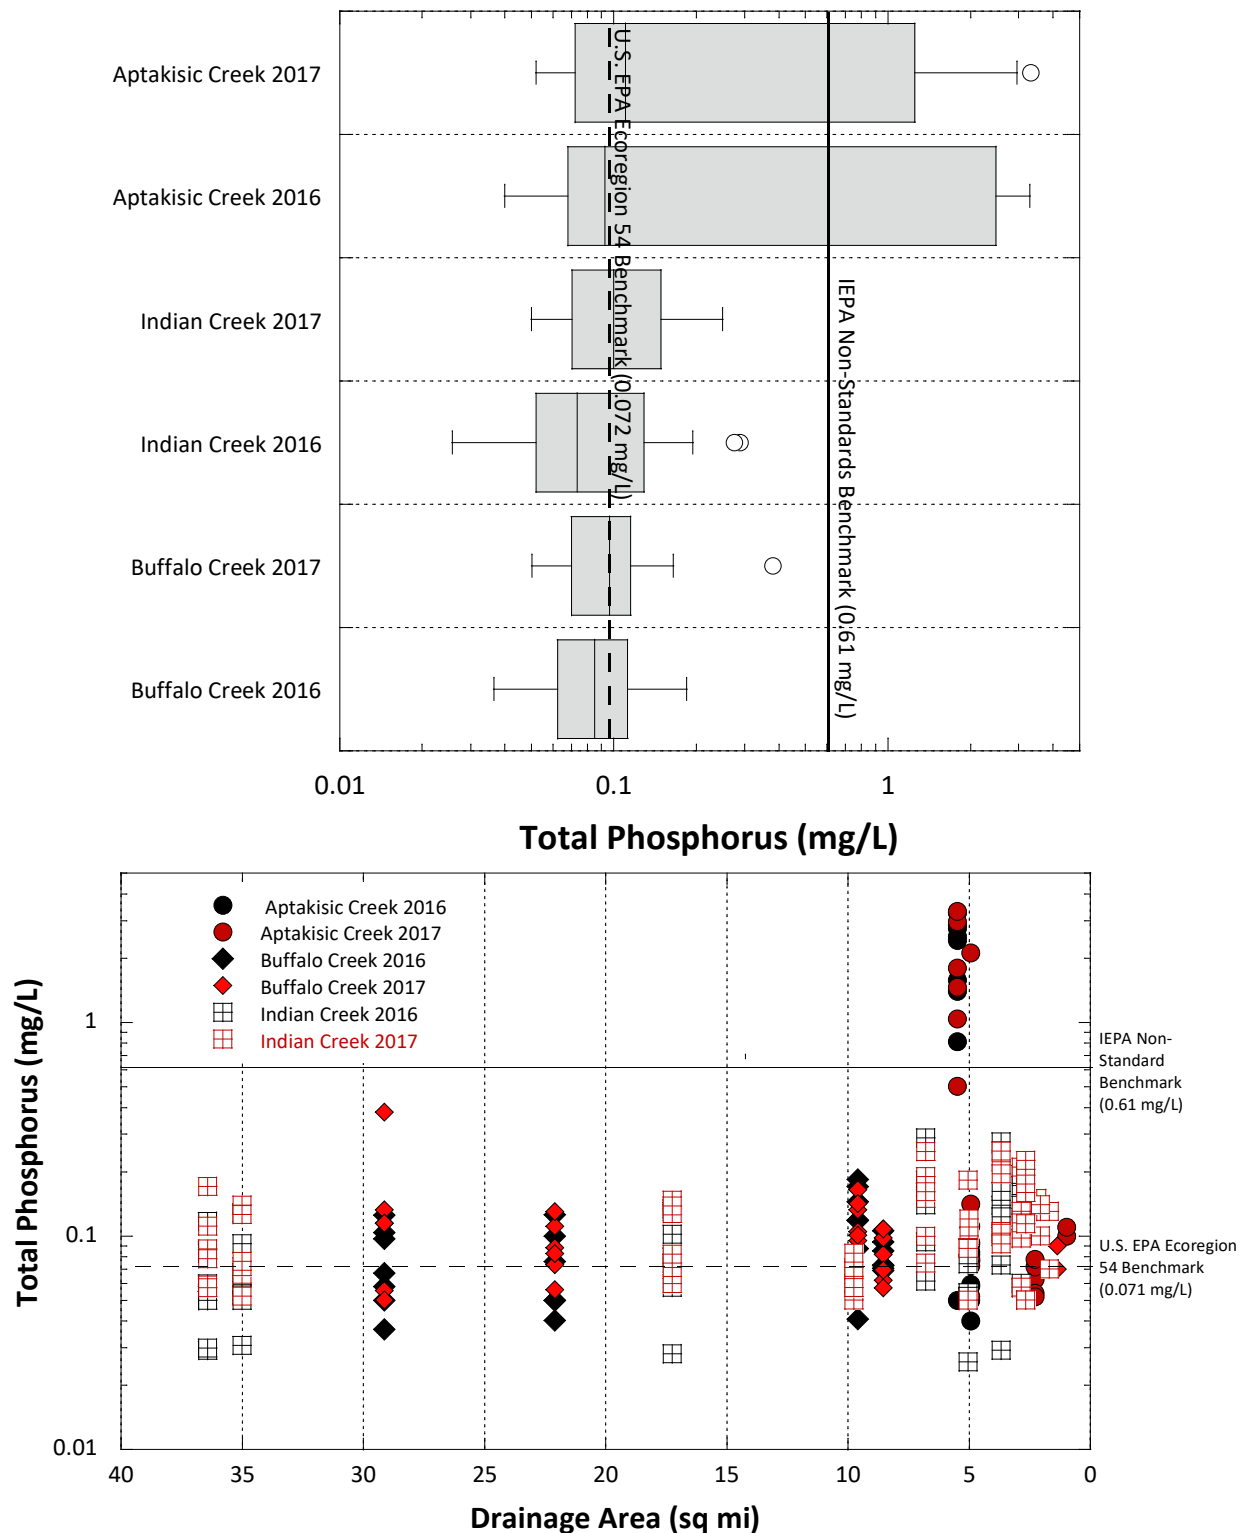
Figure 8. Concentrations of total phosphorus by subwatershed and stream in the Year 1 2017 study area. Raw values in tributary subwatersheds are shown as box-and-whisker plots (upper panel, shaded boxes) and by individual site by drainage area (lower panel) in 2016 and 2017. Dashed and solid lines represent regional reference and IEPA non-standard (not effect based) thresholds.

Total phosphorus levels varied widely in the 2017 study area with median values in 2016 and 2017 close to or below the U.S. EPA Ecoregion 54 reference value of 0.07 mg/L to peak values of 0.15-0.40 mg/L at all sites except Aptakistic Creek with a slight increase with stream size (Figure 8). Total P values of 2-3 mg/L were measured downstream from the Lake Co. Des Plaines River WWTP an obvious indication of enrichment by that point source (Figure 8, lower panel). The role of total P and other indicators as a contributor to overall nutrient enrichment effects was considered as part of the modified SNAP procedure (Ohio EPA 2015b).
